Manhole Inspection Summary

Manhole # S37MM_018MH

Insp Date: 1/31/07 3:12 PM

Location Address: **514 21ST ST**

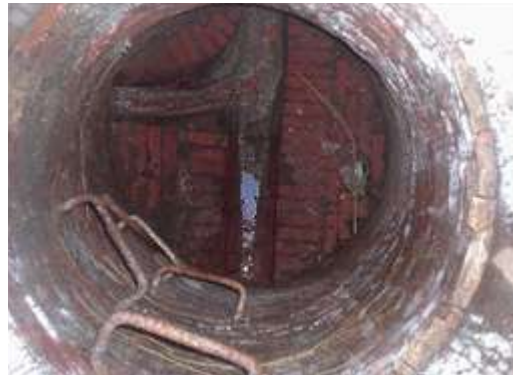
Top View

Corroded steps. Evidence of surcharge - Bench debris.

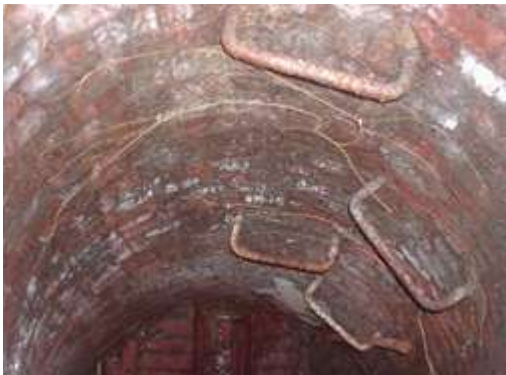
Defect

Adjustment infiltration. Corbel and Barrel root intrusion and infiltration.

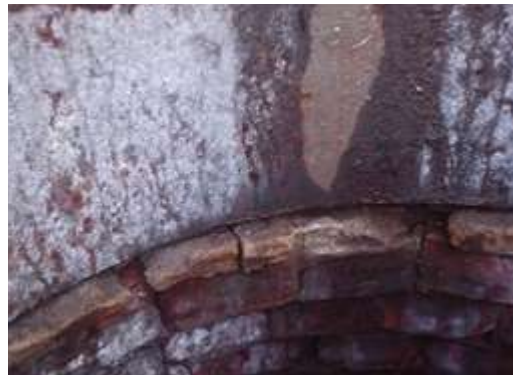
Defect

Frame leaks. Adjustment deterioration, loose brick and infiltration.

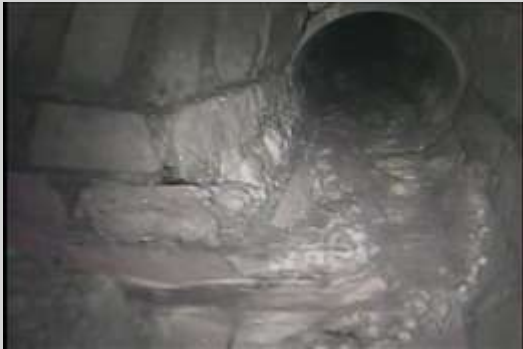
8 in. Circular Gravity Sewer Pipe Out @ 12 O'Clock

Channel deterioration.

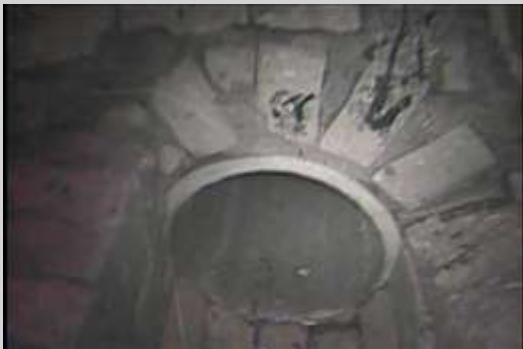
8 in. Circular Gravity Sewer Pipe In @ 6 O'Clock

Barrel deterioration and infiltration.

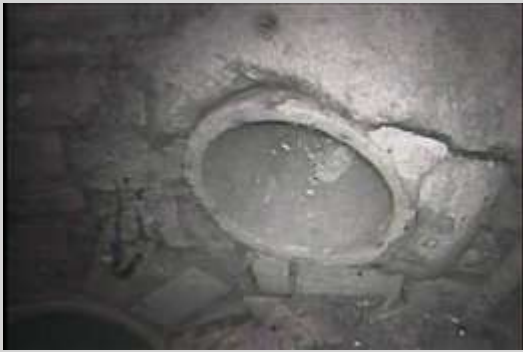
Pipe In @ 7 O'Clock

Barrel deterioration and infiltration.

Infiltration: **Evidence** Pipe Seal Cond: **Cracked**

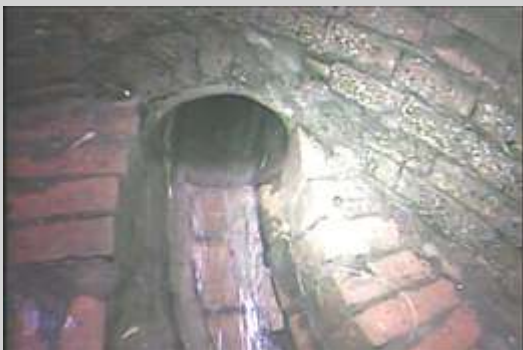
Pipe In @ 9 O'Clock

Barrel deterioration and infiltration.

Infiltration: **None** Pipe Seal Cond: **Cracked**
